## MATERIAL: Electroplated copper-lead bearings alloy

## MATERIAL: Aluminum alloy bearings

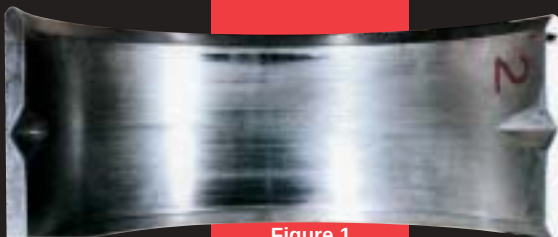
Figure 1

Both halves display a good "running" appearance. The overplate is well preserved and the contact pattern with the crankshaft is correctly located in the center. The scoring from foreign matter, visible in the bottom shell, does not impair the reliability of the bearing. This pair can be reused.

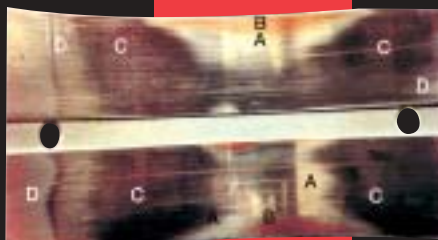
Figure 3

This shell displays small areas (A) of visible nickel barrier, areas of exposed copper-lead lining (B), a darkened running layer - due to tin migration - (C) and no signs of wear on the overplate. This bearing may be reused.

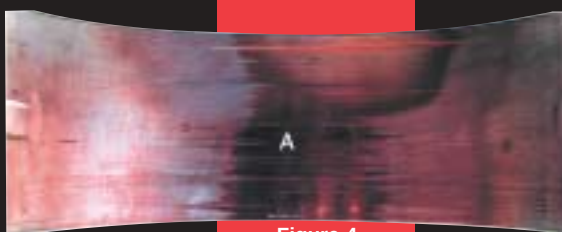
Figure 4

The dark area (A) displays the remains of the overplate, which is only preserved in about 70% of the contact area. Some circumferential scoring lines, caused by hard particles, are also visible. Although the wear condition appears normal, this bearing could be only conditionally used.

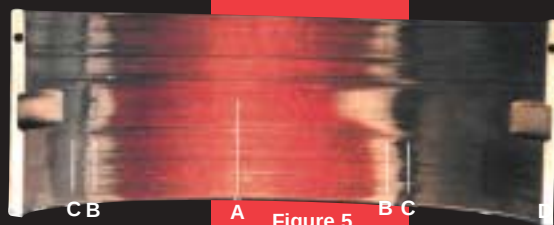
Figure 5

After 39,000 hours of service this bearing displays normal wear, but it must be replaced due to (A) lining exposure because of wear, (B) worn nickel barrier, and (C) darker discoloration due to tin migration.

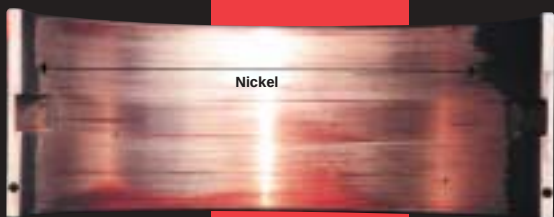
Figure 6

In this example, the overplate is almost totally gone due to mechanical wear and corrosion. Large areas of the nickel barrier are visible, with no transitional phase in the wear pattern. This bearing must be replaced because it has no "running in" capability.

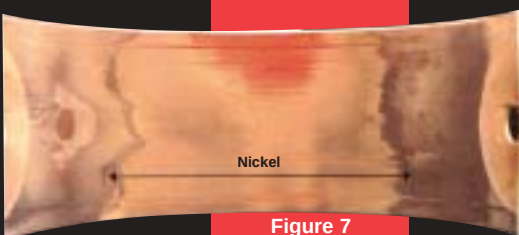
Figure 7

The electroplated running layer of this bearing has been worn out in a large area by corrosion and mechanical wear - also notice the exposed nickel barrier. This bearing must also be replaced.

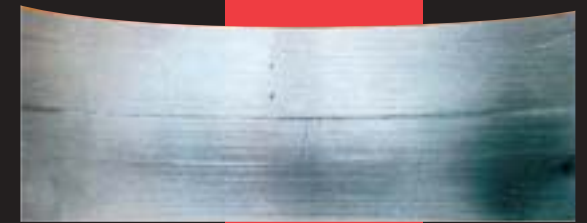
Figure 1

Since the light scoring observed has no influence in the performance of the bearing, and the good, uniform contact pattern is across the entire surface, this shell can be reused.

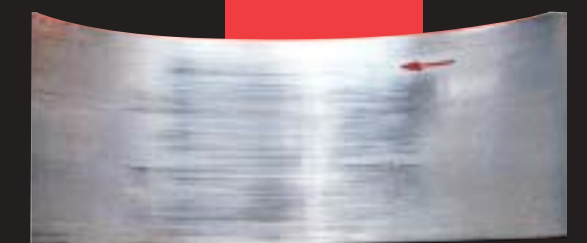
Figure 2

This is another example of a good, uniform, contact covering the whole bearing width. This bearing may be reused.

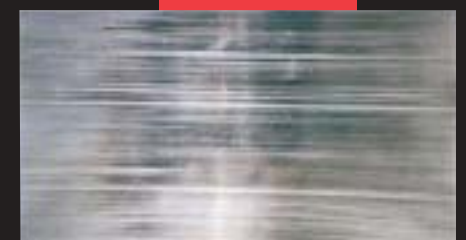
Figure 3

The contact pattern has uniformly developed, covering the whole bearing width. The circumferential scoring on this bearing is caused by minute solid particles in the lubricating oil. The bearing may be reused ONLY if the depth of these scores is not measurable or tangible.

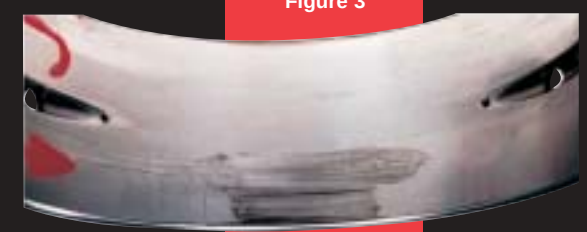
Figure 4

The contact pattern of this bearing displays highly loaded areas toward the edges as well as corrosion within the aluminum alloy running layer. The cause of these damages have to be investigated and eliminated before the replacement of the bearings.

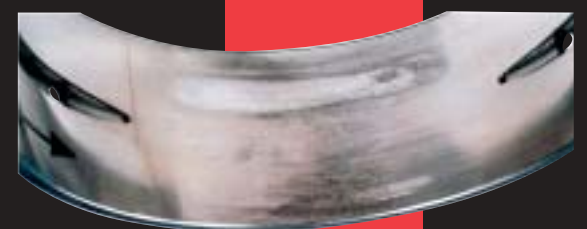
Figure 5

A large damaged area, with different degrees of seizure, is evident on this shell. The bearing is not reusable and its cause of distress must be determined before replacement.

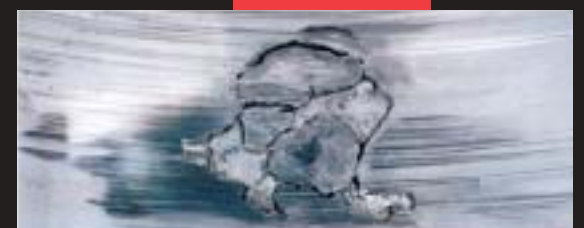
Figure 6

This bearing shows fatigue cracks and particle detachment in the aluminum alloy lining. The surface structure at the bottom of the cracked off areas, indicates good bonding of the aluminum alloy to the steel back. It is obvious that this shell can not be reused.

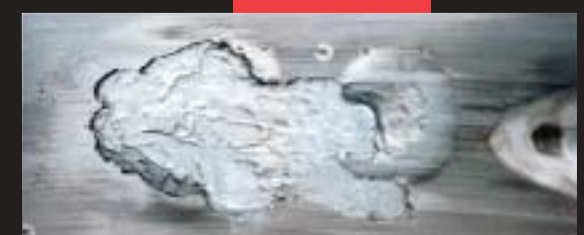
Figure 7

This bearing displays similar damage as the example above but in a further stage of destruction. Again, the surface structure of the bottom indicates excellent bonding of the aluminum alloy to the steel back.
